WEST BRANCH DAM CT 00101

NAUGATUCK RIVER BASIN TORRINGTON, CONNECTICUT

PHASE I INSPECTION REPORT NATIONAL DAM INSPECTION PROGRAM

Re: West Branch Dam a/k/a Church Street Dam

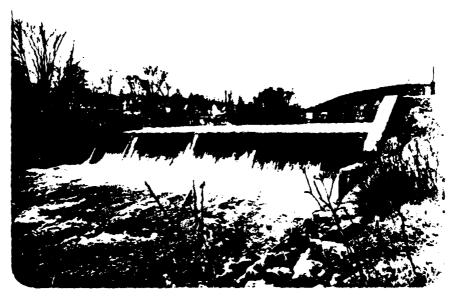
PHOTO NO. 1

SPILLWAY AND RIGHT TRAINING WALL*
